Lessons learned from pre-emptive replacement of mooring lines in West Africa

Alain Ledoux
Total S.A.

The experience: Pre-emptive replacements due to chain corrosion

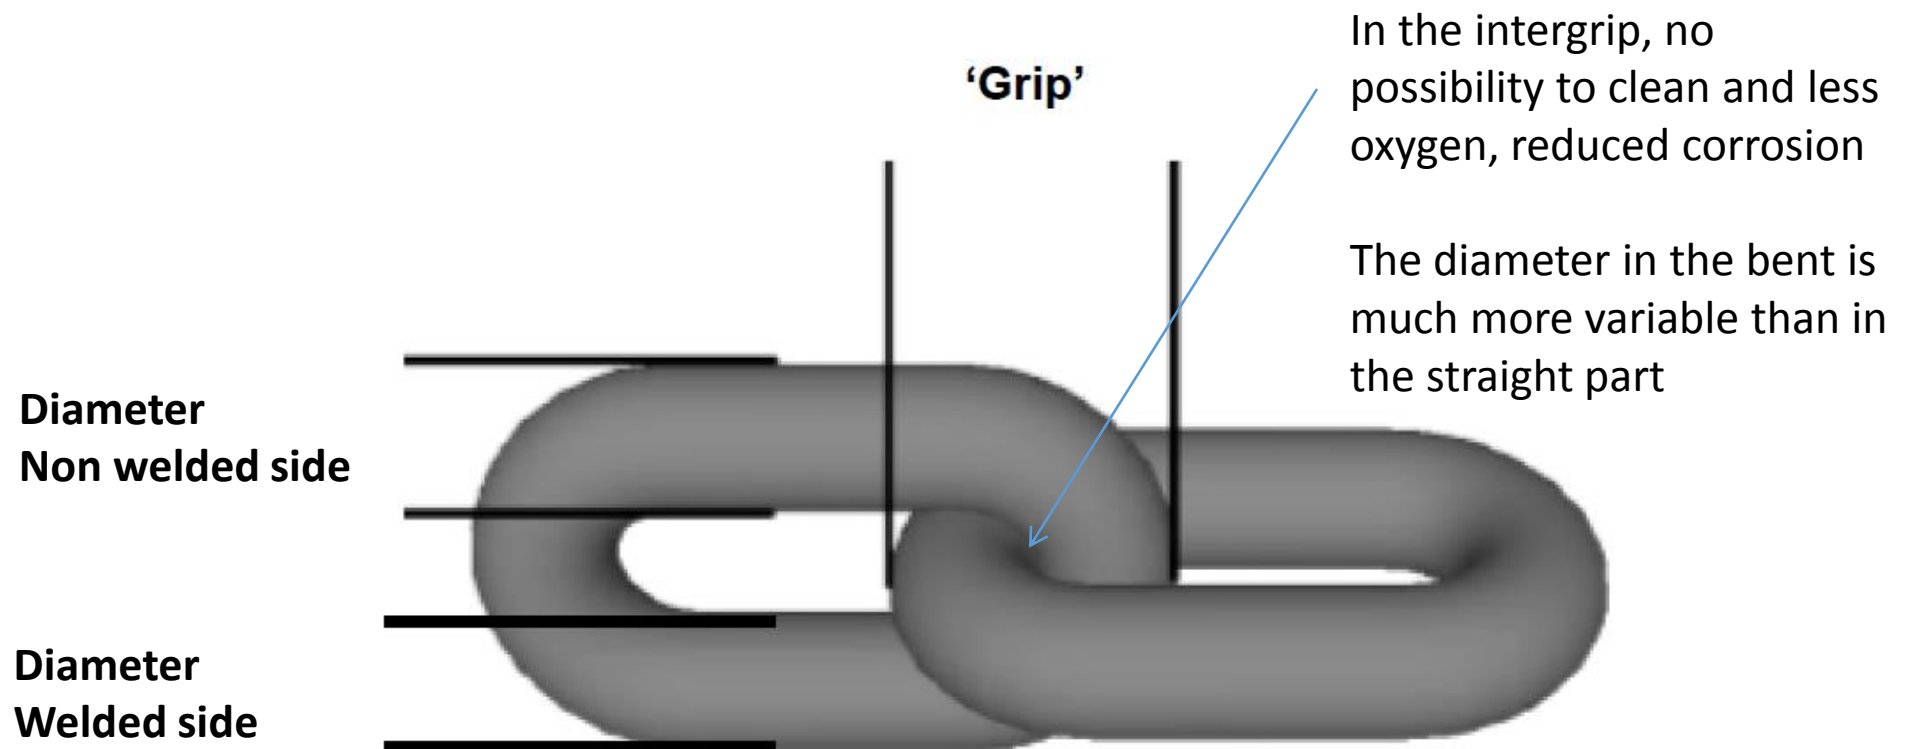
Diameter measurement

API 2I recommends to measure the grip
in mild environment and with respect to uniform corrosion
More pertinent to measure **diameter on the non welded side**

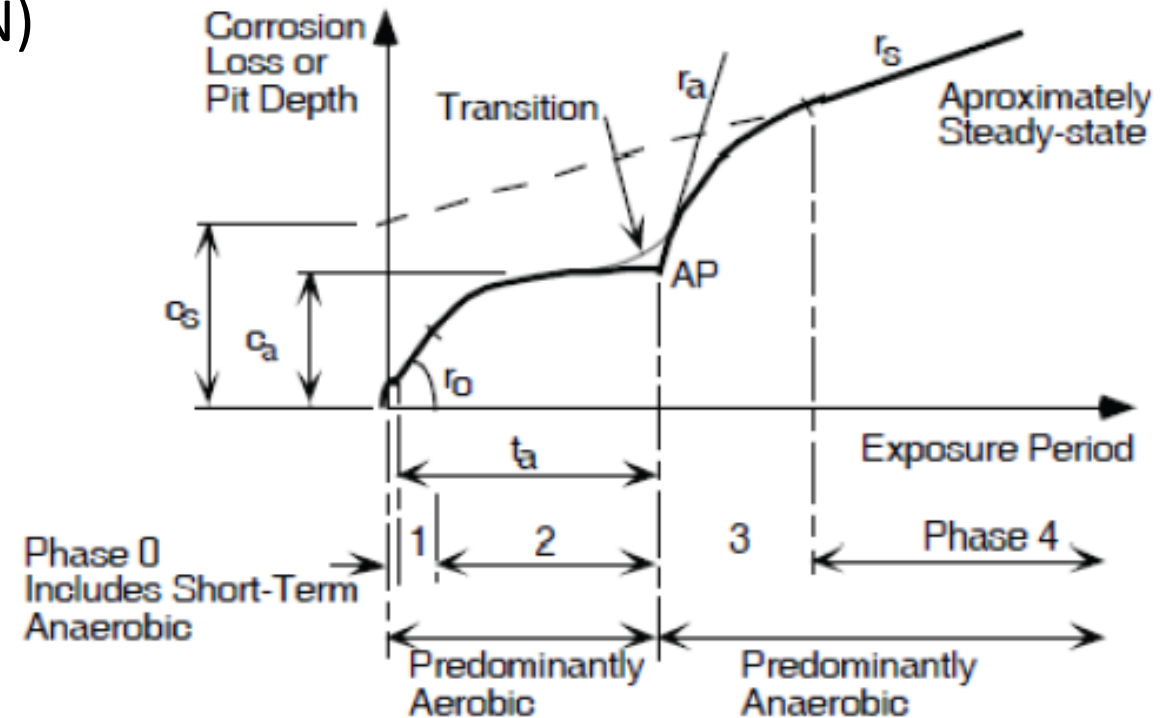
Splash zone

Model 6.6mm

Measured 16mm

Under splash zone, model 4mm, measured between 1 and 5mm

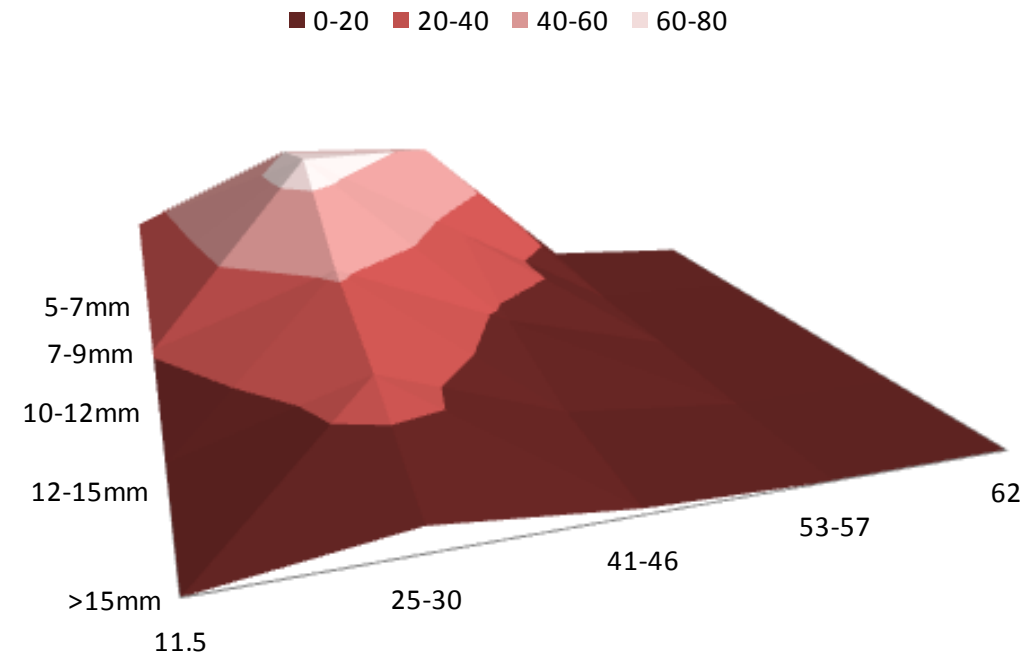
Observed nearly 8000 links

Pitting distribution wrt size (depth mm) and water depth

Water depth (m)	5-7mm	7-9mm	10-12mm	12-15mm	>15mm
11.5	34	28	21	8	0
25-30	60	68	42	27	8
41-46	57	34	17	6	2
53-57	4	1	1	0	0
62	0	0	0	0	0

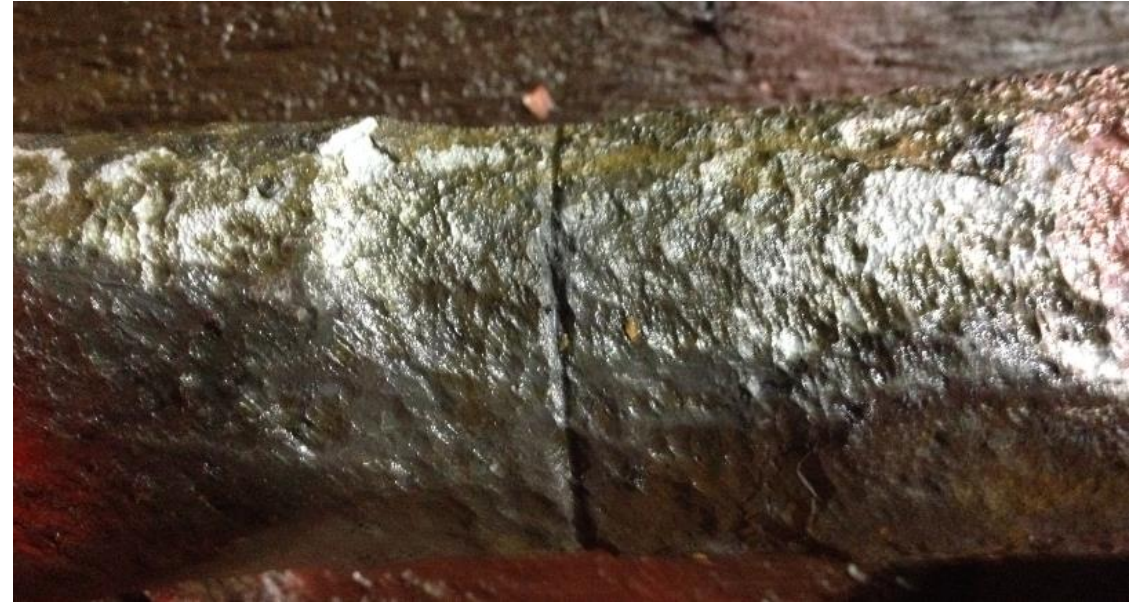
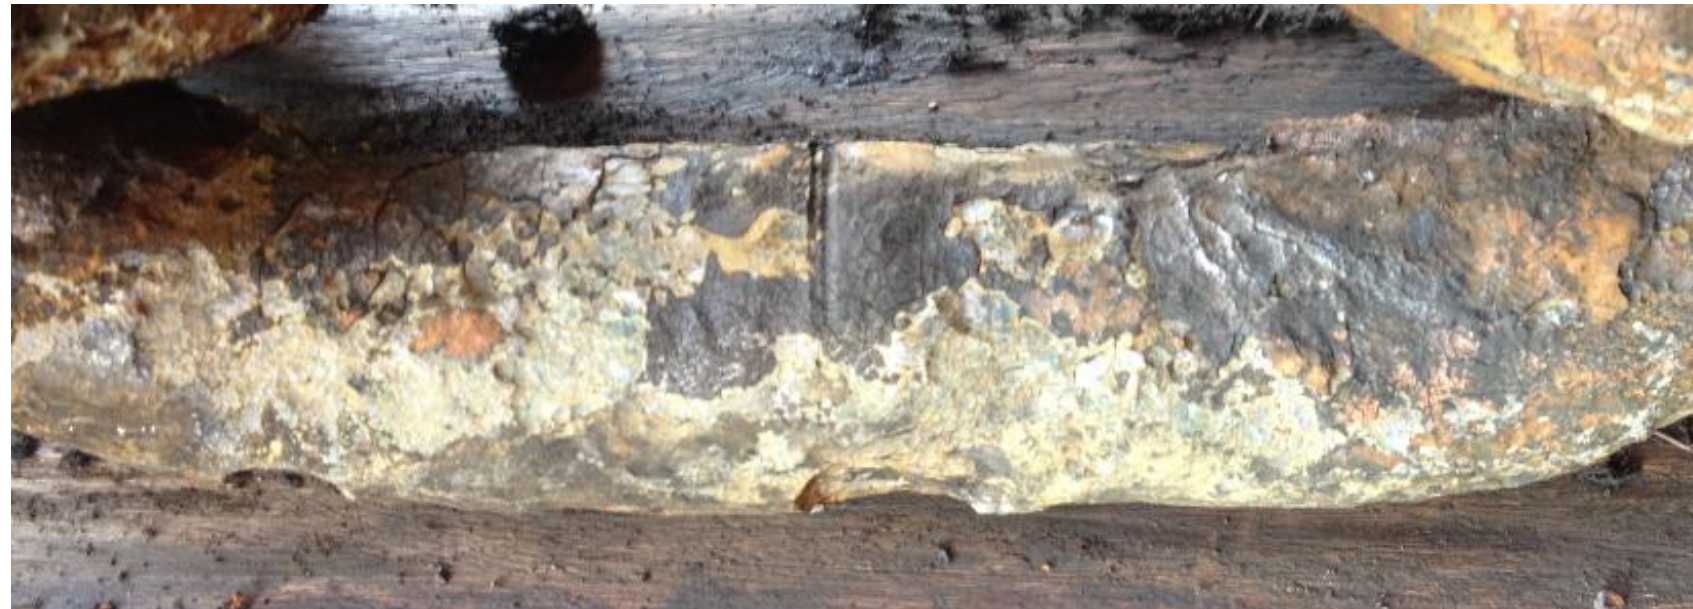
Weld preferential corrosion

2 to 35 indications per line
randomly distributed
depth < 3mm.

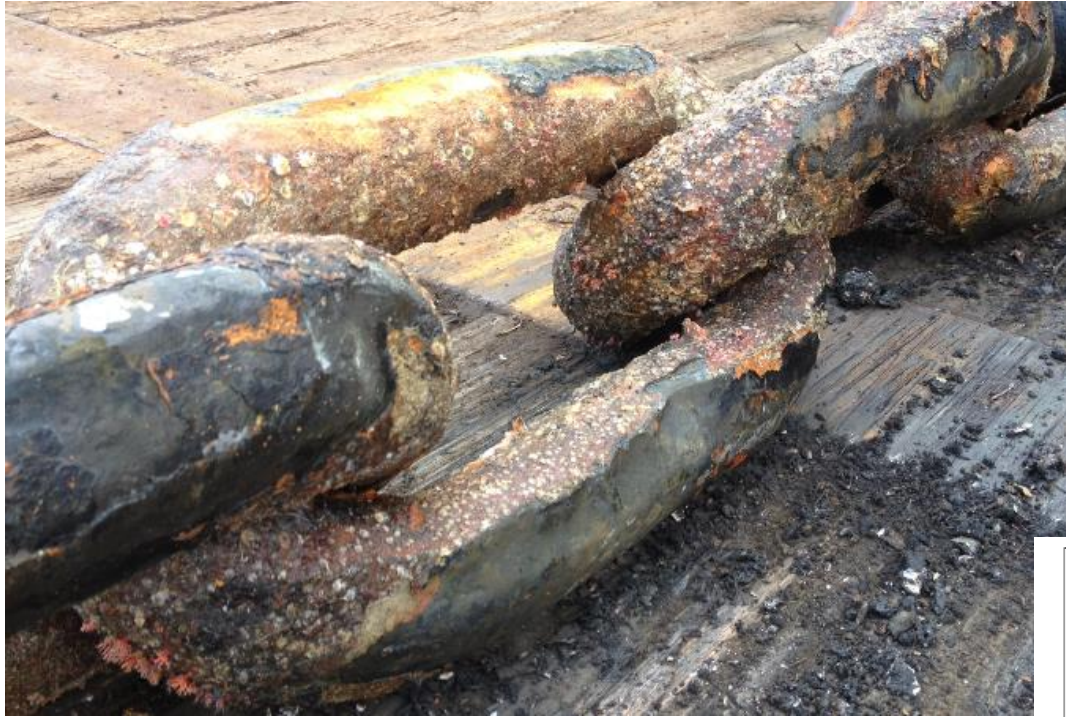
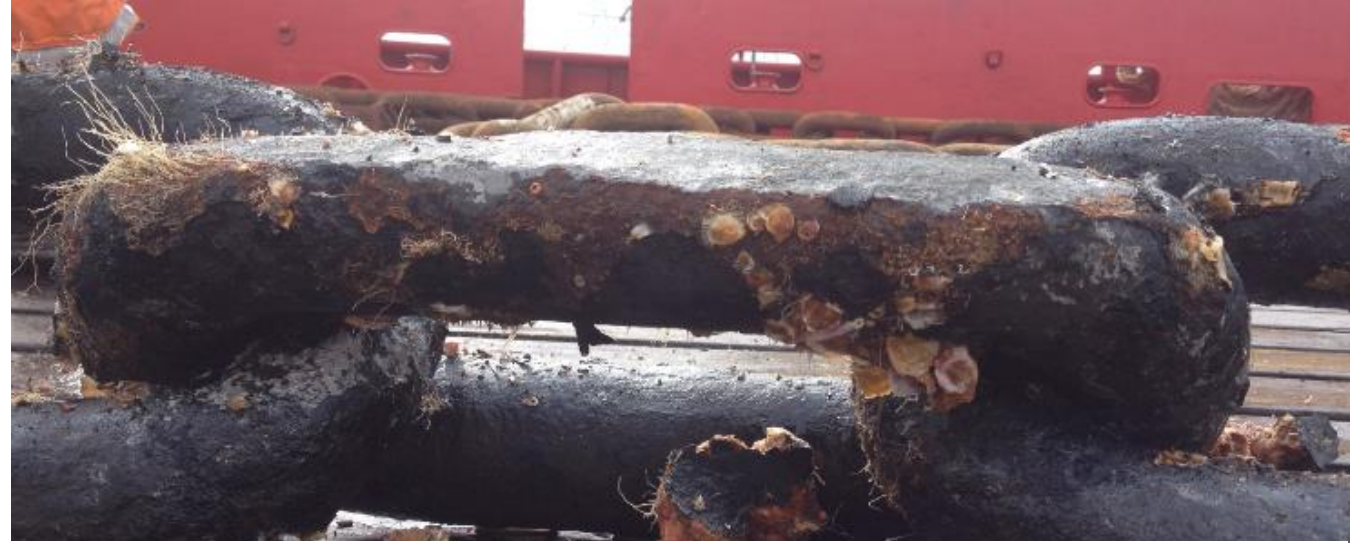
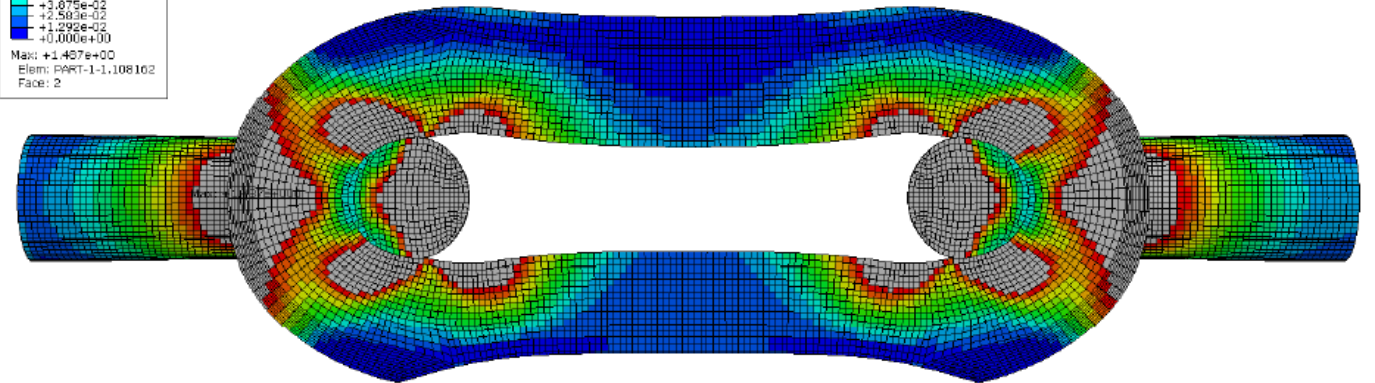
Abraded corrosion around thrash zone

Strength
Not so critical

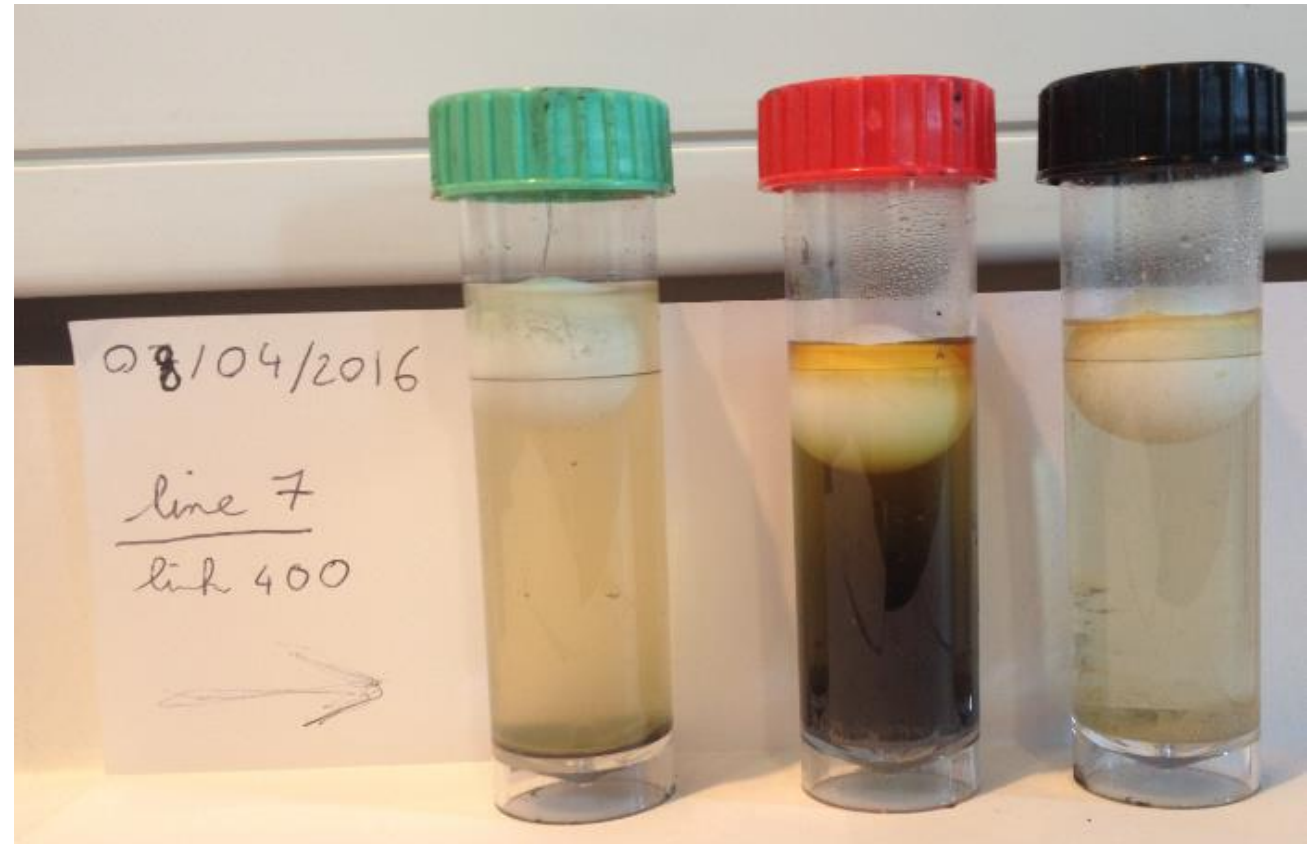
Microbiologically Induced Corrosion

BART Tests

IRB positive

Slime negative

SRB negative ??

Samples for more advanced test on-going
