Permanent Weldless Deepwater Repair Strategies

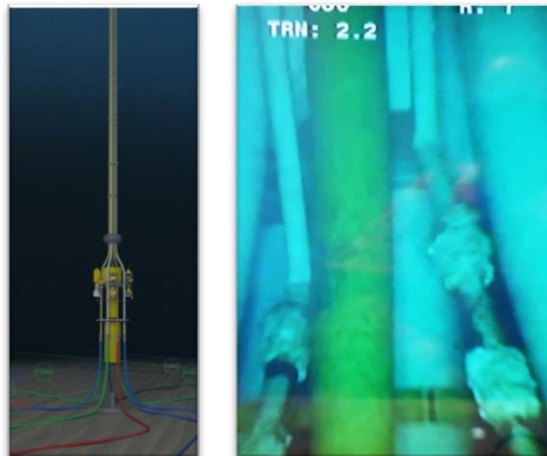
Figure 7: Location of damage

Two 4" gas lift risers at the base of a hybrid riser system were damaged during the original deepwater installation operations in the Atlantic Ocean, Offshore Angola. To ensure future production, it was essential that the damaged sections were bypassed.

Located in water depths varying between 1,200 meters and 1,500 meters, the damage to the risers was at 1,300 meters making this one of the deepest repairs ever attempted and with the risers secured in the bundle near the base of the tower, would require a completely new repair strategy implementing a solution deployable in a restricted environment, 50m above the seabed.

The solution had to be permanent (in accordance with DNV F101/F113), of proven technology (TR6 or above in accordance with API 17N) and suitable for confined space envelopes. Remote Mechanical Connectors are a field proven method of repairing pipes in deepwater, so the challenge lay not with the design of the permanent repair method, but the means of installation without support from the surface or the seabed.

In order to deploy a connector repair, the damaged pipe would have to be released from the riser bundle, the coating would then have to be removed and the correct cuts made. Without overstressing the riser, the connector would then have to be aligned, installed, activated and tested allowing the new flexible jumper bypass to be attached.

To support the completed repair, a high-load structural clamp would have to be permanently fixed to the riser bundle, providing a means to limit the motion of the new repair spools. All work would need to be conducted by ROV in 1300mwd, approximately 50 meters above the seabed.

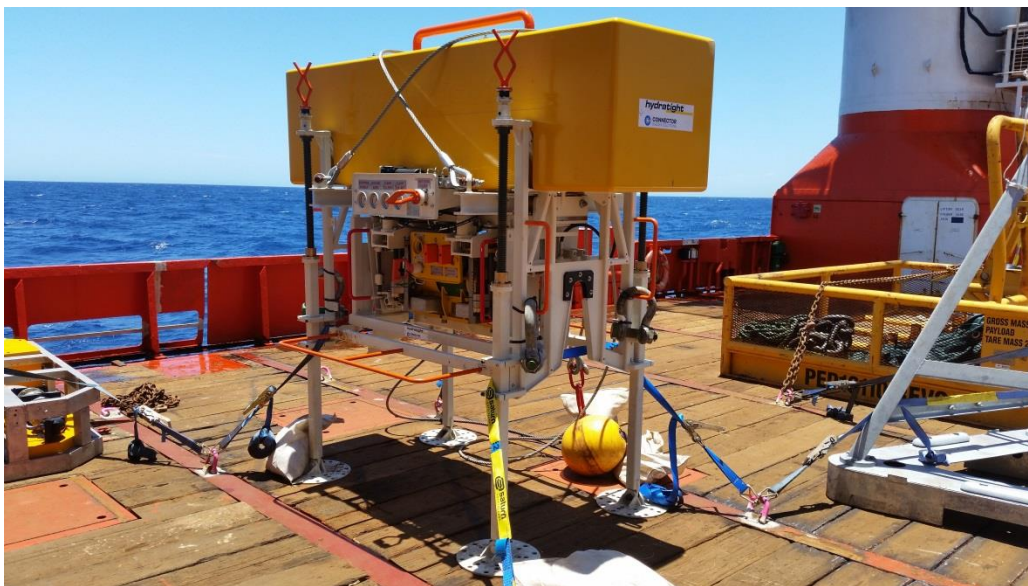
Figure 11: Remote boltless clamp with external activation tool

A major NOC experienced a deepwater pipeline fracture offshore Western Australia which required urgent repair. A fracture was detected on a 400bar four-inch MEG line, located at 830m. The Operator required a permanent, field - proven repair on a minimal lead time. Due to the location and environment the entire project had to be carried out remotely, using ROV compatible tooling. Furthermore the weight of the repair had to be minimal so as to not overstress the pipe.

The need for a high pressure repair conflicts with the requirement for a low weight solution. Typically in order to achieve a high seal pressure the seal needs to be put under a very high load stress. The load is typically transferred through bolting – the higher the load, the larger the bolting and the surrounding material to react from.

A clamp was custom-fabricated for the specific requirements. All activation system technologies and hydraulics were within a separate retrievable tool, to reduce weight, fatigue and cost. It would ensure that the fracture was repaired rapidly and with minimal impact on the underwater environment. A high-performance ROV-based Coating Removal Tool was also supplied to ensure the interface between the pipe and clamp was as required, removing all sea-growth, debris and the original protective coating to provide a clean surface for the repair.

Once in location, the system was deployed leading to the successful repair of the pipeline - an innovation milestone for the industry.
